Association of Irrigated Residents  
Tom Frantz, President  
29389 Fresno Ave  
Shafter, CA 93263

March 25, 2020

Re: Complaint about buried oil field drilling sumps on prime farmland

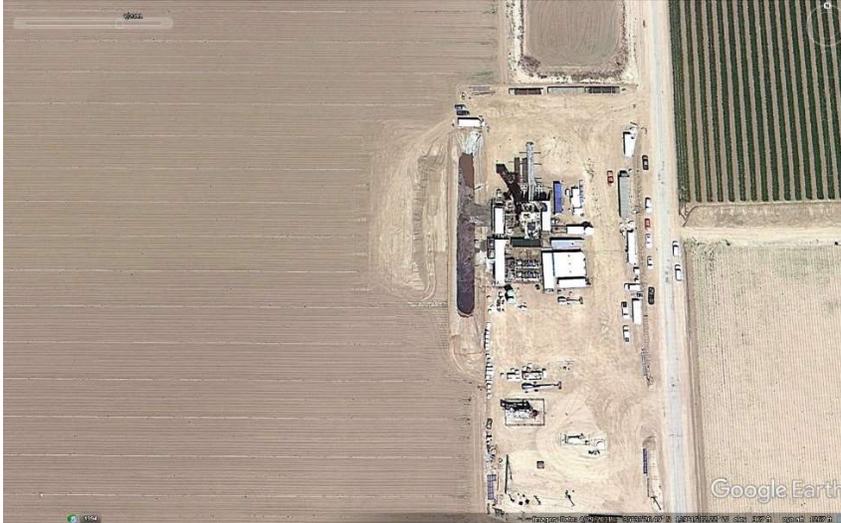
*Figure 3 Google Earth land during drilling*

During the drilling of this well, shown below by this April 2011 Google Earth photo, the location of the drilling sump and drilling equipment is clearly visible. Notice the north or upper end of the drilling sump where there appears to be foreign material deposited other than drilling mud.

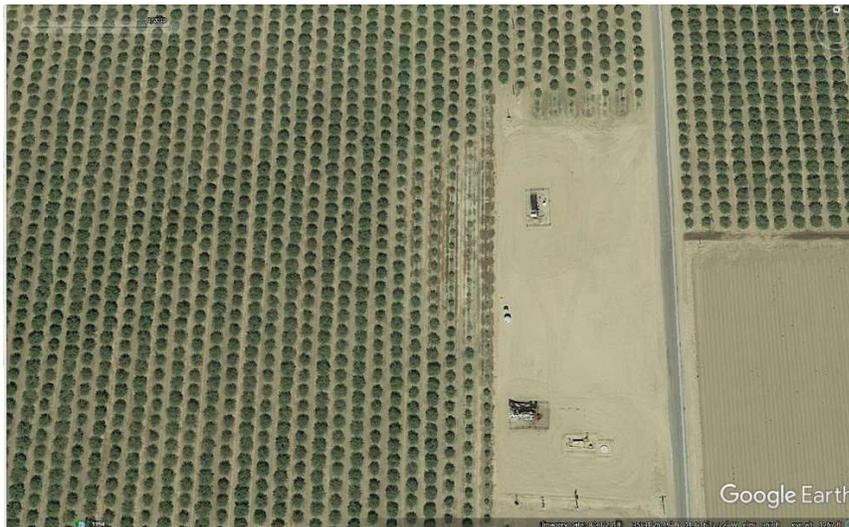
*Figure 4 Google Earth land after drilling and replanting*

In this August 2018 Google Earth photo, the drilling sump area has been planted to almond trees, along with the rest of the field. The almond trees in the sump area and on the north edge of the cleared site are not growing well. Many have died and some have been replanted but not successfully. The area is under drip irrigation.

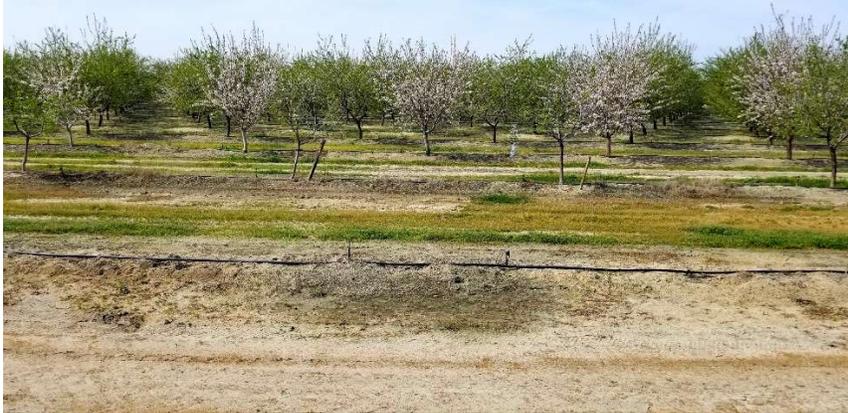
*Figure 5 sump area with dead almond trees*

Below is a March 2020 photo taken at the site of the drilling sump where almond trees in the first three rows are struggling to grow, unlike in the rest of the field where the trees are healthy and much larger.

Inspection and thorough soil testing must take place at these two sites with appropriate follow up action including remediation to protect groundwater used by nearby farmers and residents!

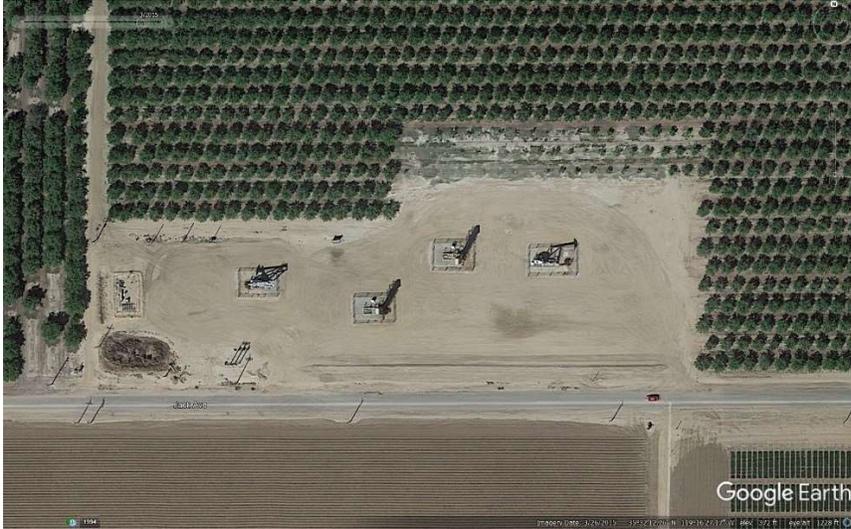
*Figure 9 Google Earth photo of land after replanting*

In this March 2015 photo below, three rows of almond trees have been replanted on the drilling sump site. The ground is visibly wet from irrigation under these three rows of newly planted trees.

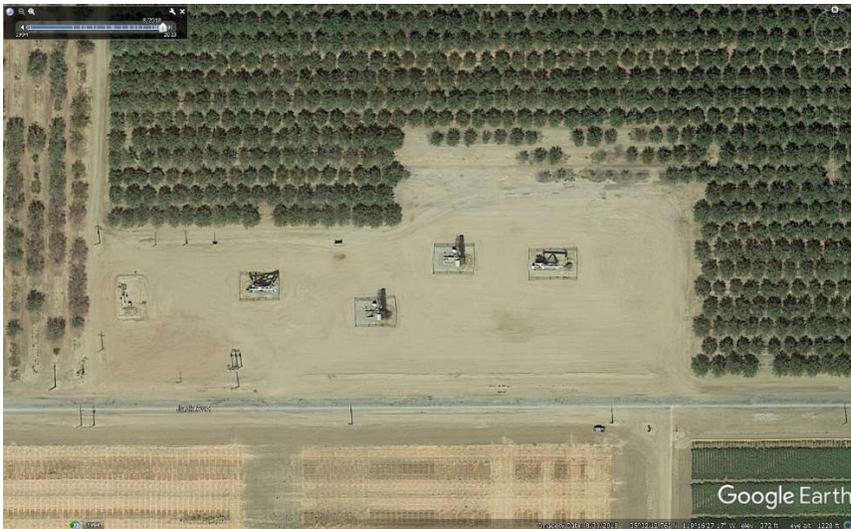
*Figure 10 Google Earth photo of most recent situation*

In this August 2018 Google Earth photo below, the three rows of trees contain many dead and missing trees, especially in the first two rows.

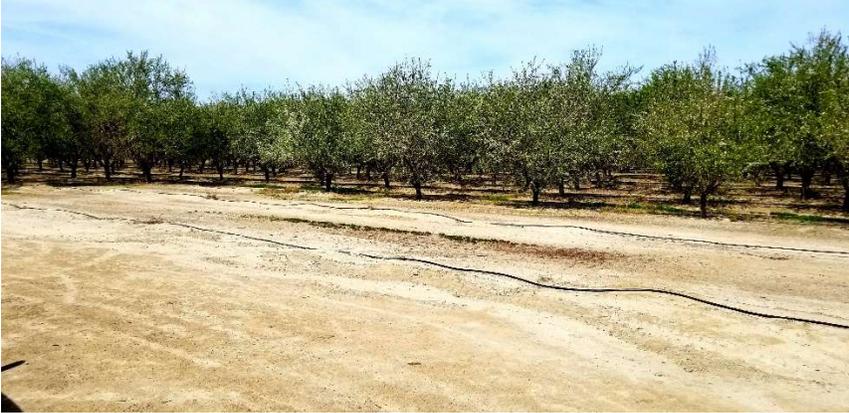
*Figure 11 Google Earth photo of missing almond trees above sump area*

This March 2020 photo below shows the area where the two rows of almond trees would not grow at all.
