Association of Irrigated Residents  
Tom Frantz, President  
29389 Fresno Ave  
Shafter, CA 93263

March 25, 2020

Re: Complaint about buried oil field drilling sumps on prime farmland

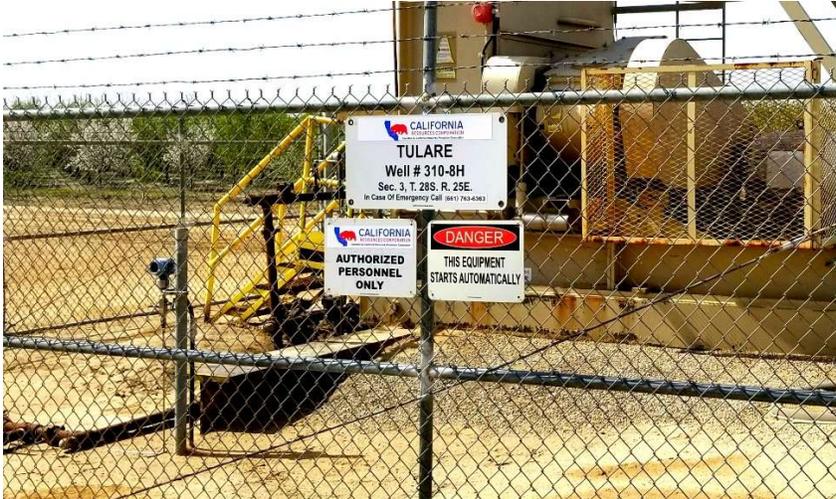
Figure 1 Oil Well TULARE #310-8H

Below is a March 2020 photo of the currently active oil well at this location.

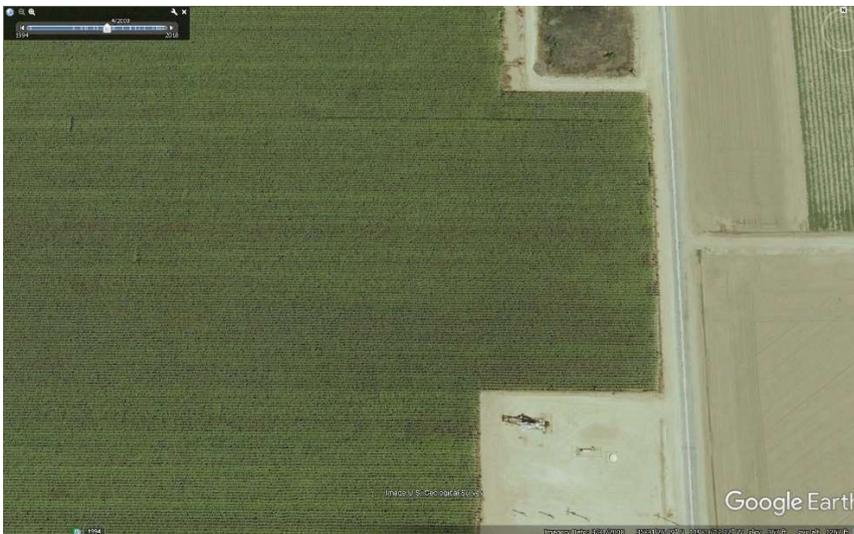
Figure 2 Google Earth land before drilling

Before this well was drilled, shown below in this April 2008 Google Earth photo, it appears that the farmland surrounding the site, in all directions, was uniformly productive and similar to the productivity in the rest of the field.

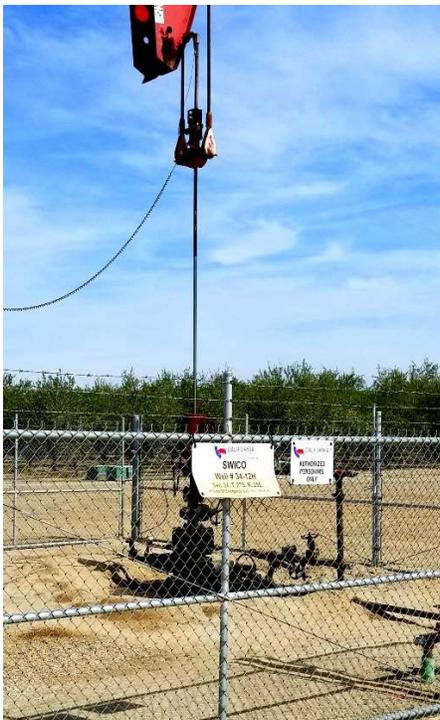
*Figure 6 Well head SWICO #34-12H*

Below is a March 2020 photo of the currently active oil well at this location.

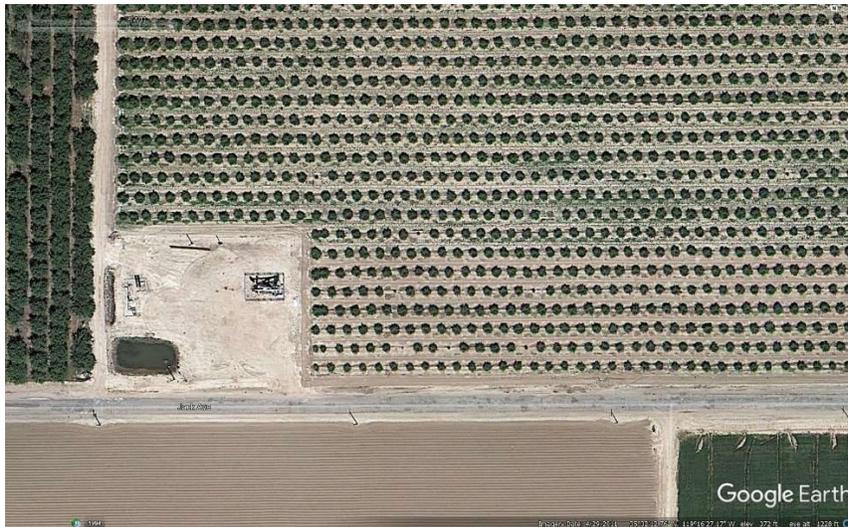
*Figure 7 Google Earth photo of land before drilling*

Before this well was drilled, shown in this April 2011 Google Earth photo, it appears that the farmland at this site, in all directions, was uniformly productive and similar to the productivity in the rest of the field. The almond trees appear young and growing normally.

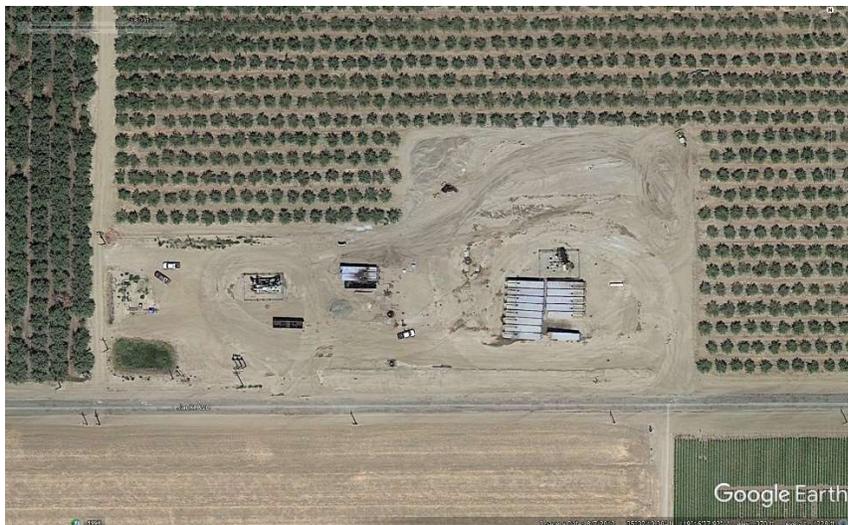
*Figure 8 Google Earth photo of land immediately after drilling and fracking*

In this August 2012 Google Earth photo, land has been cleared, two or three wells have been drilled, and the area of the related drilling sump is being smoothed over by equipment. Water tanks from drilling and fracking are visible.
